# TERRESTRIAL LASER SCANNING IN ENGINEERING SURVEY: ANALYSIS AND APPLICATION EXAMPLES

**Attila Berenyi, Tamas Lovas, Arpad Barsi**  
Budapest University of Technology and Economics,  
Department of Photogrammetry and Geoinformatics  
[aberenyi,tlovas]@mail.bme.hu, barsi@eik.bme.hu

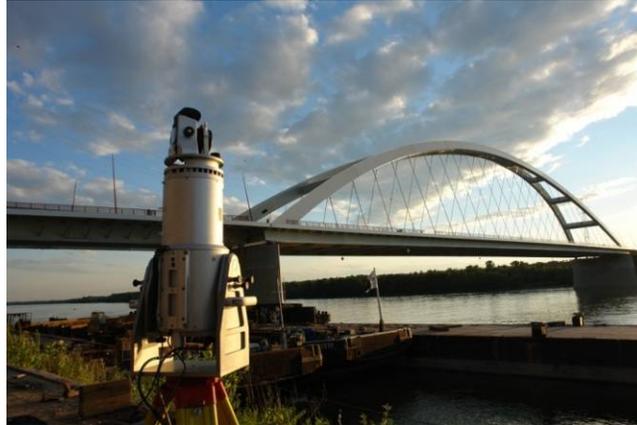
Since only one scanner was available, the proper selection of the scanning position was critical; the most characteristic points of the bridge should be captured. Considering the available measurement time windows and the measurement range of the scanner, the station was selected at the left river bank (Fig. 1).

**Figure 1.** Laser scanning the Pentele Bridge.

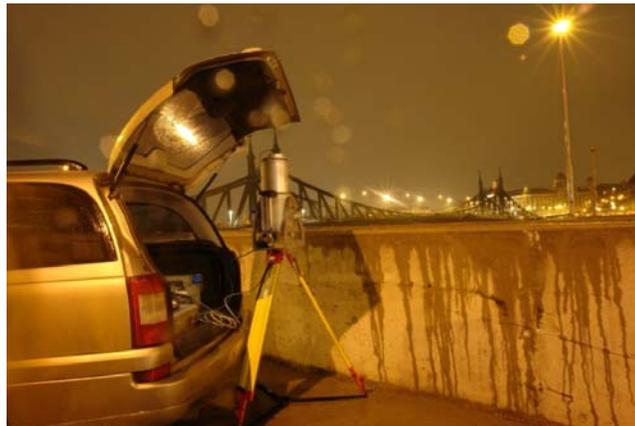
Because the ambient temperature was close to the minimum value (0 °C) of the operation limit, and because of the hard weather circumstances (rain, later snow) the scanner was deployed under the trunk-lid of a car (Fig. 6). The lid defended the scanner from the rain and the car's heating system ensured a bit higher temperature for the scanner.

**Figure 6.** Scanning position, Szabadság Bridge.

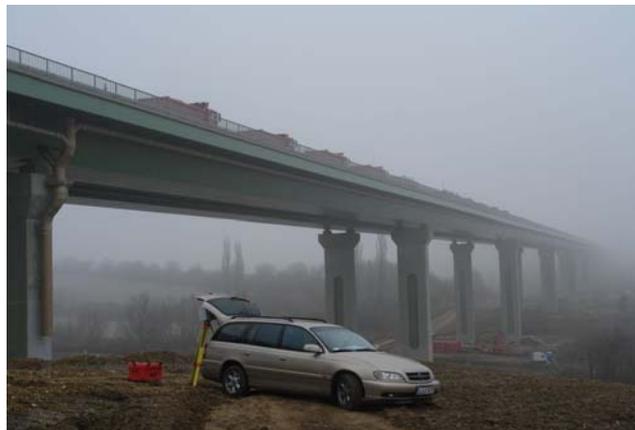
Laser scanning the load test of the Szebényi Bridge resulted interesting experiments. The measurement was done in January 2010 at low temperature (-4-5 °C degrees). The applied Leica C10 scanner enabled scanning in this extreme temperature range. This motorway viaduct spans above a valley that enabled to set up the scanner close to the bridge ensuring ideal scanning angles and even scanning from a station under the bridge (Fig. 9).

**Figure 9.** Scanning station at Szebényi Bridge.

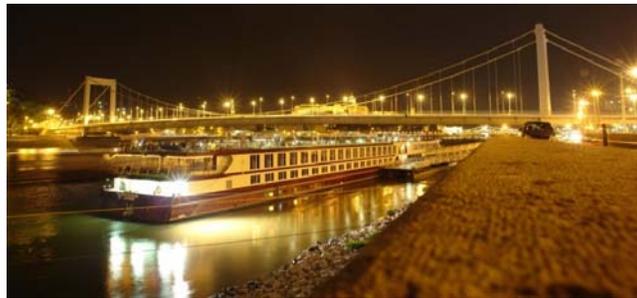
In addition to bridge load test measurements the technology was tested in different civil engineering applications as well. One of these is the investigation of the effect of ambient temperature on steel bridges. The authors have chosen Erzsébet Bridge (Fig. 10), a cable bridge with a span of 290 m, thus reacts relatively fast for small changes in the ambient temperature, and has the specialty, that both of its pylons are standing on the Danube bank, not in the river.

**Figure 10.** Erzsébet Bridge from the first scanning station.

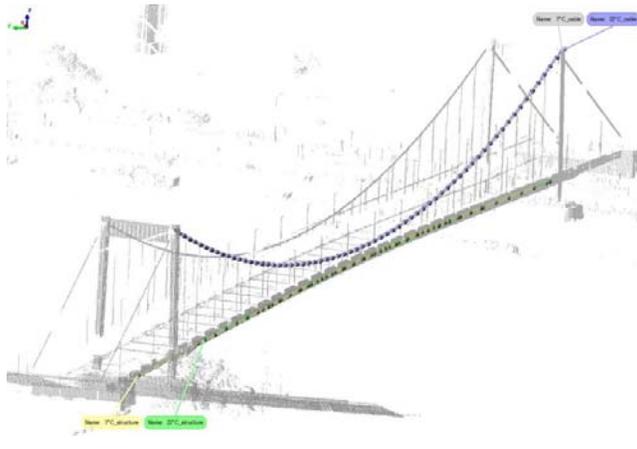
**Figure 11.** Modeling the main cable and the deck.

The post process included the analysis of the vertical displacement of the main cable and the deck: the fitted polylines on these elements are shown on Figure 11. Considering the first as reference the differences were investigated; the results showed maximum difference (i.e. the vertical displacement of the main cable) of 12.8 cm in the middle of the main cable. The displacement values were determined from deck's point clouds as well. The exact values were calculated indirectly, because from the scanning position only a small part of the deck was visible, however other structure elements (e.g. pavement, handrail) that move together with the deck were easy to be identified and analyzed.
