DEVELOPMENT OF A MULTI-SENSOR SYSTEM FOR ROAD CONDITION MAPPING

A.Miraliakbari, M. Hahn

KEY WORDS: Spectrometer, Camera, Laser scanner, GPS/INS, Sensor Integration, Road Condition, Mapping

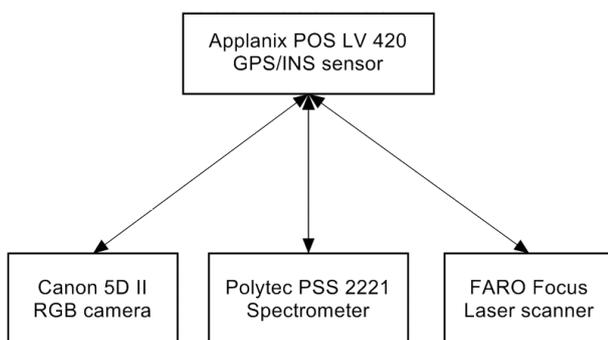
Figure 1. Sensor system used for road condition mapping

A GNSS-aided inertial navigation system (GPS/INS) sensor (Applanix POS LV 420) together with an RGB camera (Canon 5D Mark II) and a laser scanner (FARO FOCUS 3D) are mounted on the top of the vehicle. The sensor head of the spectrometer (Polytec PPS 2221) is fixed at the backside of the vehicle in order to keep the distance between the road surface and the sensor small (30 to 50 cm). Figure 2 shows the laser scanner, RGB camera and the spectrometer head. Aim and purpose of this sensor setup is to collect suitable data for investigating the condition of road pavement.

At the University of Applied Sciences in Stuttgart, we have started to equip vehicles with sensors for mobile data collection some years ago. The overall goal of this development is to support research and teaching with a highly configurable system. One of these configurations is visualized in **Error! Reference source not found.**

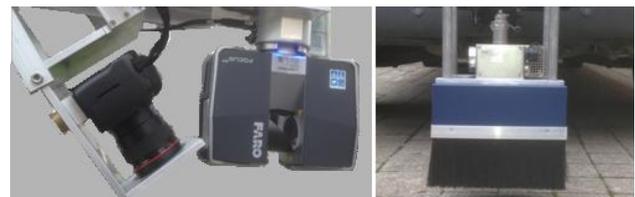
Figure 2. Canon camera, FARO laser scanner and Polytec spectrometer head

Digital RGB images are taken together with the spectrometry data. By mounting the camera in nadir view the back side of the vehicle would be visible in the images. Therefore the images are recorded in an oblique view (Figure 2) and are ortho-rectified in a post-processing step. The image capturing is performed either with a constant time increment, e.g. every second or with a constant path increment e.g. every 2 m. The RGB images support the investigations carried out with the spectrometer data. Further they will be used for automatic detection of asphalt failures, in particular for cracks.

The laser scanner is pointing nadir in order to achieve a maximum point density on the road. For mobile laser scanning, the FARO Focus^{3D} X330 instrument is equipped with a so-called helical adapter. 8533 points have been recorded per scan rotation (limited to 300°) at a line scan speed of 97 lines per second. The laser line spacing in the direction of travel amounts to 8.6 cm when driving at the speed of 30 km/h. Within the line, a sampling distance of a few mm is achieved on the road surface.

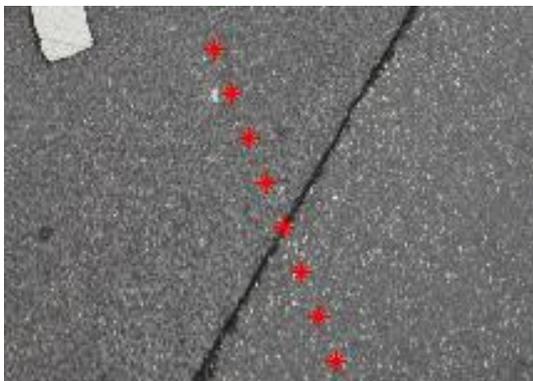
Figure 3 shows the location of the spectrometer spots overlaid onto the RGB image. The vehicle was driving at a speed of ca.17 km/h.

Figure 3. The location of spectrometer recordings. The example shows a dense sampling distance of about 15 cm.

One of the spectrometer spots covers a crack (Figure 3) which shows up in the spectral signatures with a lower reflectance than those spectra recorded at neighbouring locations, see Figure 4. This indicates that the lower reflectivity appears not only in the visible (Figure 3 shows the colour image) but also in the infrared domain between 1200 nm and 2300 nm.

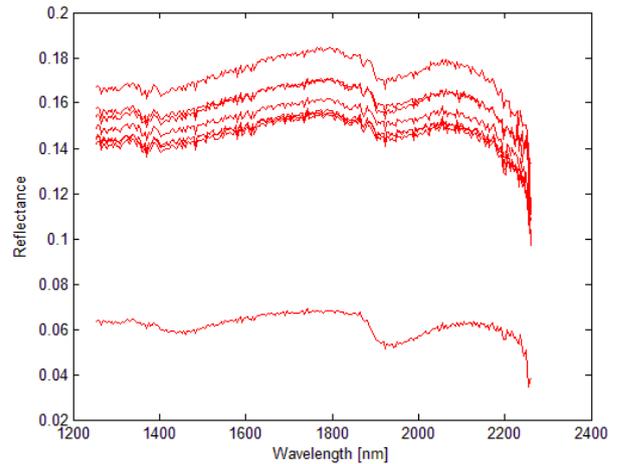
Figure 4. Reflectance of the spectrometer spots on the ground shown in Figure 3.

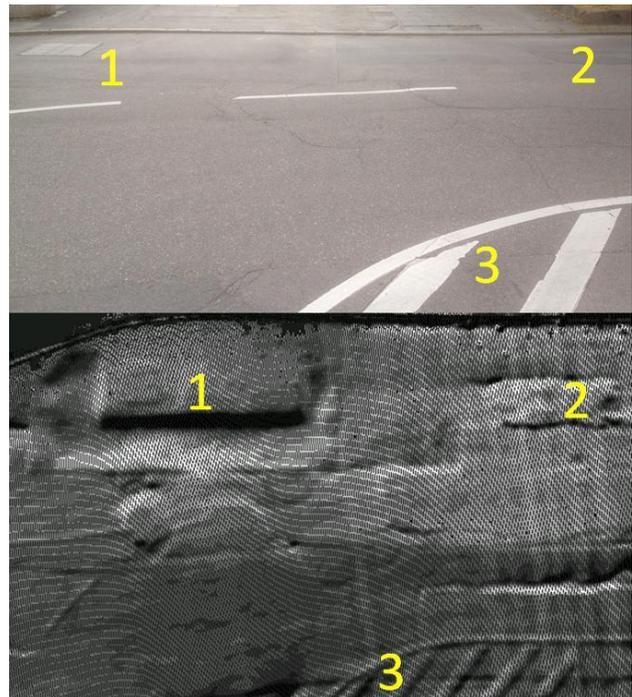
Figure 5 shows an RGB image of a road section and the shaded relief of the corresponding laser point cloud. That the surface shape of the road around locations 1, 2 and 3 differs from a smooth surface can be easily recognized in the laser data but not in the RGB image.

Figure 5. RGB image (above), shading from the laser point cloud (below)

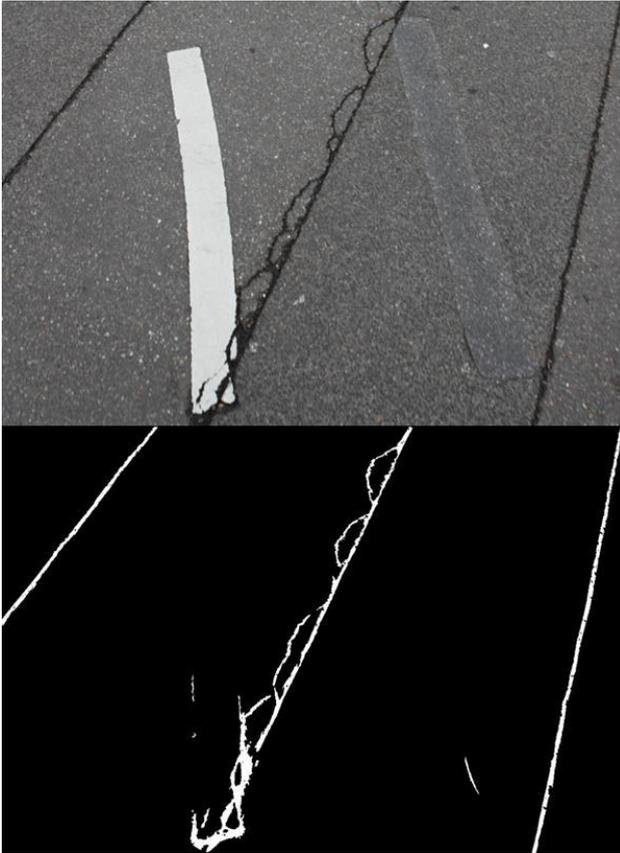
Figure 6 shows first results of crack detection in the RGB image.

Figure 6. Crack detection (below) using RGB image (above)
