Application of Landsat Imagery to Shoreline Erosion

Areas susceptible to erosion in Croatan and Pamlico Sounds, North Carolina were identified.

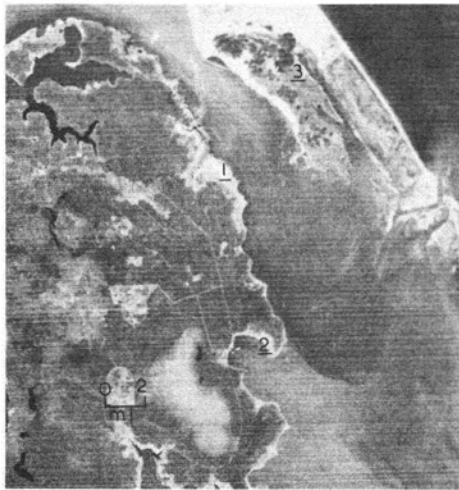
FIG. 2. Movement of water from Albemarle Sound through Croatan Sound. White area north of Roanoke Island is ice. 1 = Long Wretch Point, 2 = Stumpy Point, 3 = Roanoke Island. Landsat-2 image, 2741-14485-5, 1 February 1977. Wind from west at estimated 5-10 kt midway in ebb cycle at Oregon Inlet.

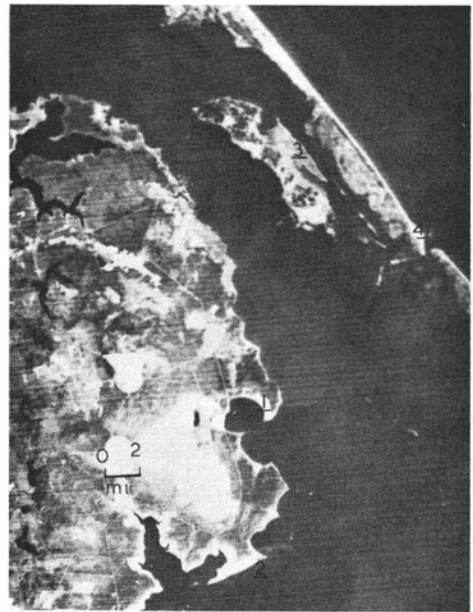
FIG. 3. Offshore movement of suspended sediment from Stumpy Point area. 1 = Stumpy Point, 2 = Long Shoal Point, 3 = Roanoke Island, 4 = Oregon Inlet. Landsat-2 image, 2363-15003-5, 20 January 1976. Flood tide at Oregon Inlet, with 5-10 kt winds from south-southwest and west for 9 hours prior to image.

Evidence concerning the effects of Croatan Sound water upon the shoreline of Stumpy Point shows that alongshore movements and sediment transport offshore (Figure 3) comprise over two-thirds of the activity. Little direct attack upon the point is suggested, and for approximately one-third of the images there is no unequivocal evidence that either erosion or deposition is transpiring. An unidentified resident of the area has indicated that extensive erosion has taken place over the last 30 or so years (R. Holman, personal communication). From its position on the shoreline of Pamlico Sound Stumpy Point should be attacked directly only when winds are blowing from the southeasterly quadrant on a rather consistent basis.
