AUTOMATED PROCESSING OF HIGH RESOLUTION AIRBORNE IMAGES FOR EARTHQUAKE DAMAGE ASSESSMENT

F. Nex, E. Rupnik, I. Toschi, F. Remondino

3D Optical Metrology Unit, Bruno Kessler Foundation, Trento, Italy – (franex, rupnik, toshi, remondino)@fbk.eu,
<http://www.3dom.fbk.eu>

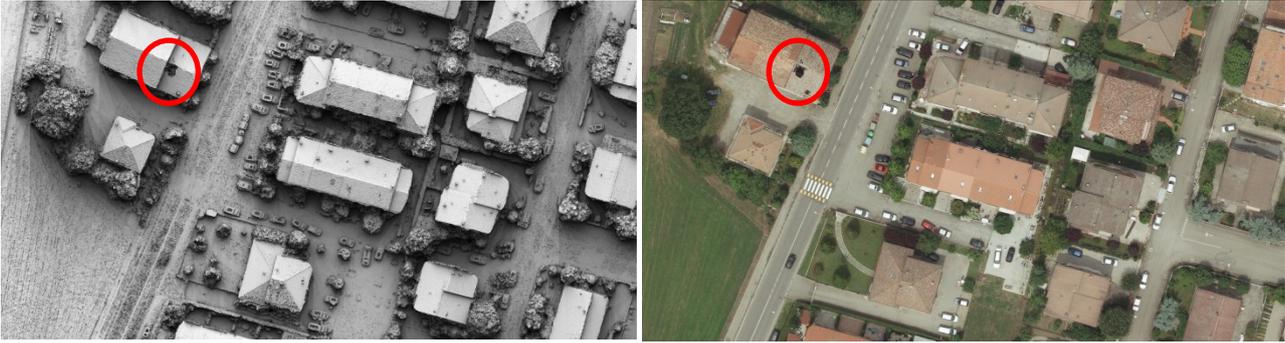
Figure 1: Generated point cloud in shaded view (a) and corresponding true ortho-photo automatically generated (b): little collapsed parts of the building are visible both from 3D and 2D data (red circles).

The algorithms assume that collapsed parts of the buildings differ from the surrounding unharmed parts of the buildings in terms of spectral information and geometry – i.e. rapid texture changes and height jumps (see Figure 1). The obtained dense point cloud is filtered in order to delete the possible blunders and noise generated during the matching process. The off-ground areas are extracted using an iterative regular grid filtering (Nex and Remondino, 2012) and building regions are then defined from the off-ground areas. In this way, points corresponding to buildings can be detected in both point clouds.
